FOCUSED SITE INSPECTION PRIORITIZATION

Clyde Dump

Clyde, Ohio Sandusky County

Date of FSIP: February 8, 1995

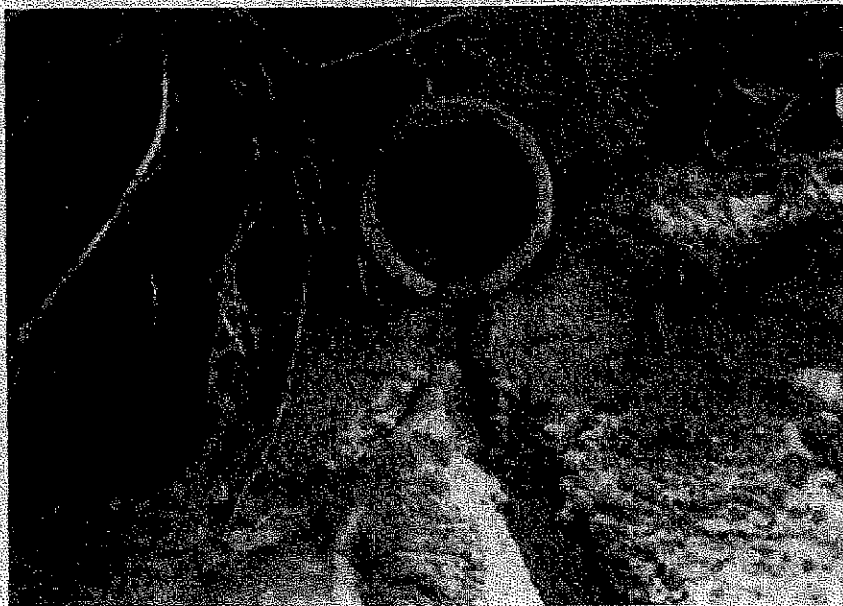
Photograph No: 3

Orientation: Picture taken facing east looking at western edge of fill area in Raccoon Creek stream bed.

Description: 10 inch clay field tile noted in photograph number 1 discharging brown/red leachate into Raccoon Creek.

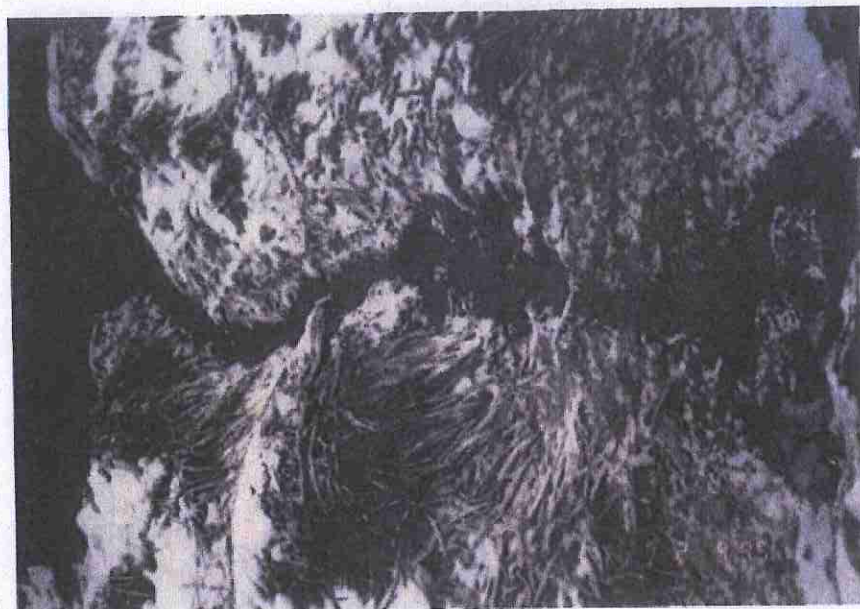
Photograph No: 5

Orientation: Picture taken looking east at the west edge of fill area in Raccoon Creek stream bed.

Description: 10 inch clay field tile embedded in concrete protruding from fill area and discharging into Raccoon Creek. Leachate is relatively clear and flowing at approximately 1 gpm. Brown sediment noted settling out of leachate.

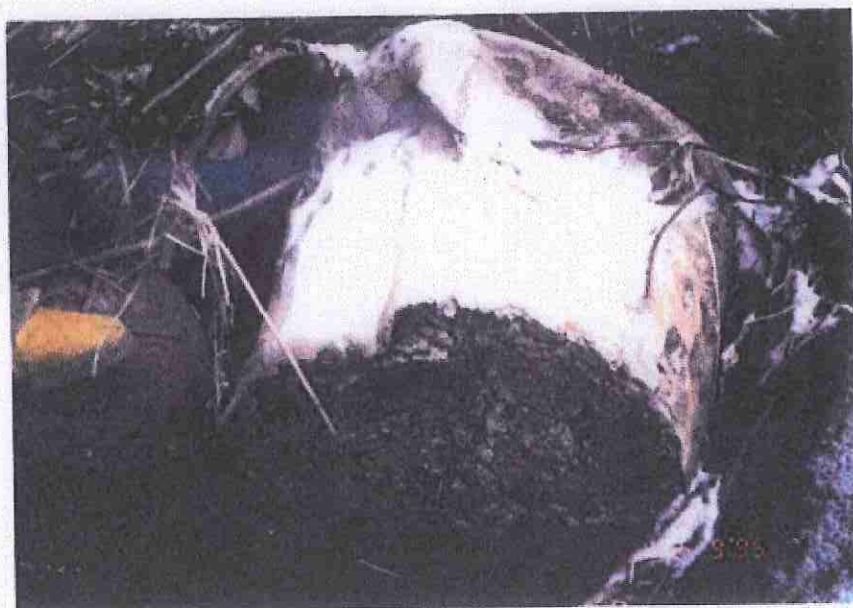
Photograph No: 6

Orientation: Picture taken looking east at the west edge of the fill area in Raccoon Creek stream bed.

Description: Solidified contents of a 55 gallon drum laying in Raccoon Creek. Waste material appeared to be paint sludge.

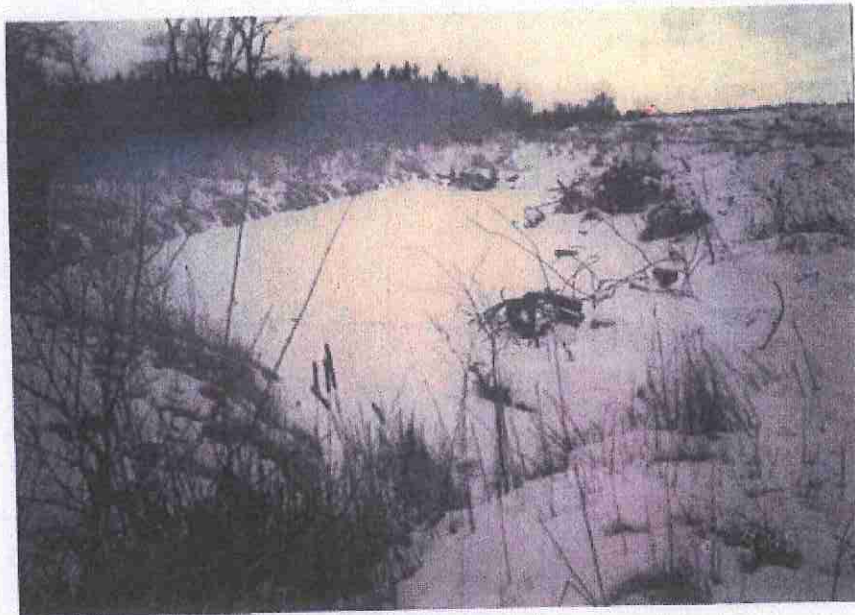
Photograph No: 7

Orientation: Picture taken facing south standing in the northeast corner of the site and looking along the eastern edge of the fill area.

Description: Ponded area in the northeast corner of the site frozen over. Ditch drains ponded area into the northern perimeter ditch. Waste is exposed in background in direct contact with ice.

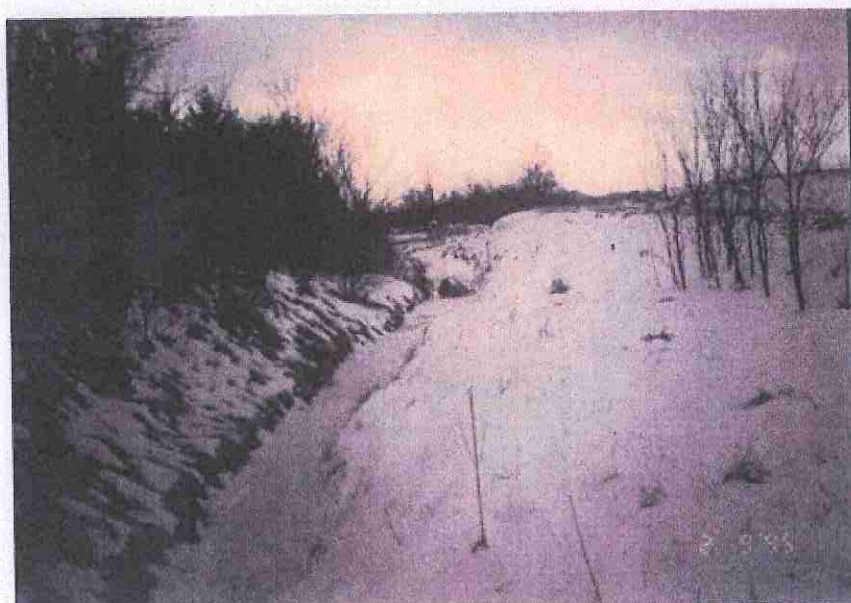
Photograph No: 8

Orientation: Picture taken looking south standing near the northeast corner of the site.

Description: Picture shows the east perimeter ditch around the fill area.

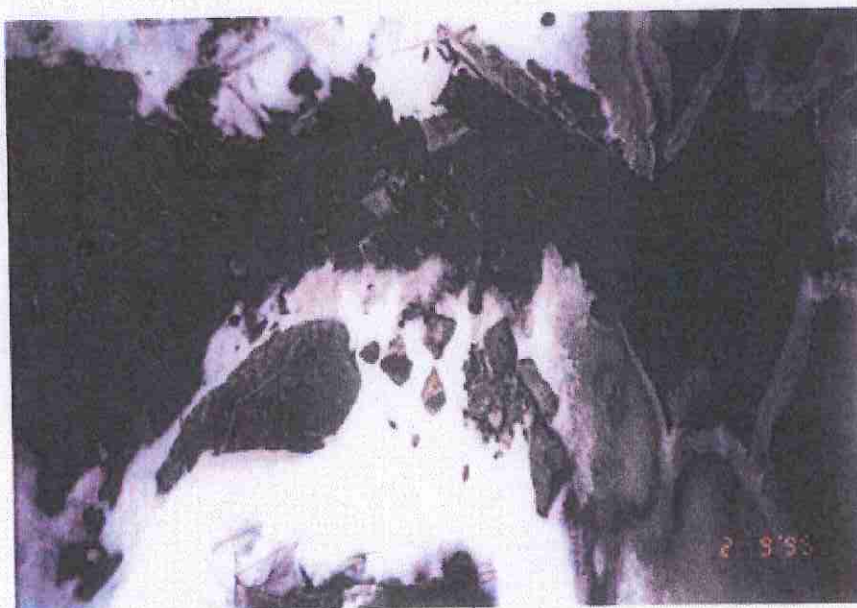
Photograph No: 10

Orientation: Picture taken looking west at the east edge of fill area near the center of the site

Description: Black Leachate outbreak discharging into east perimeter ditch beneath a large rock protruding from fill area.

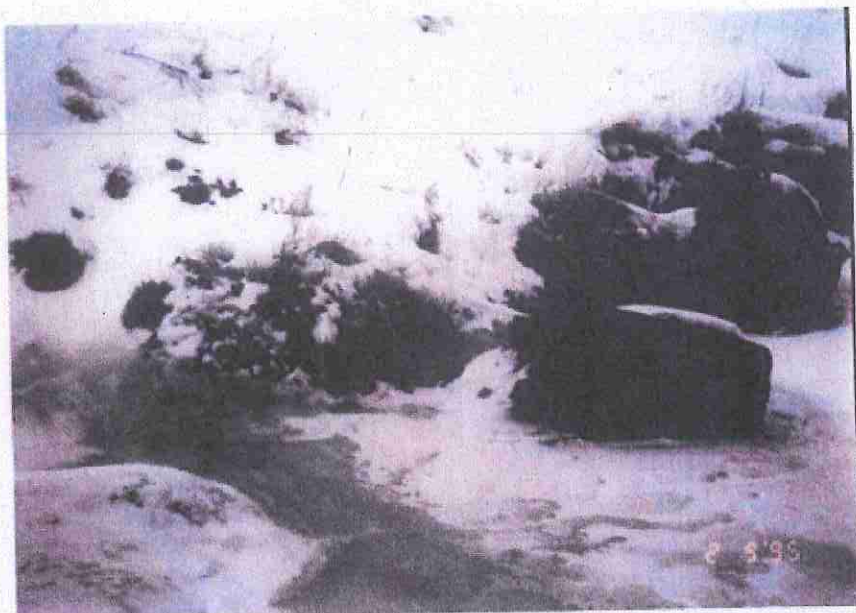
Photograph No: 11
Date: February 8, 1995
Orientation: Picture taken looking northwest at the east edge of fill area near the center of the site
Description: Brown/red Leachate outbreak discharging into east perimeter ditch near two 55 gallon drums.

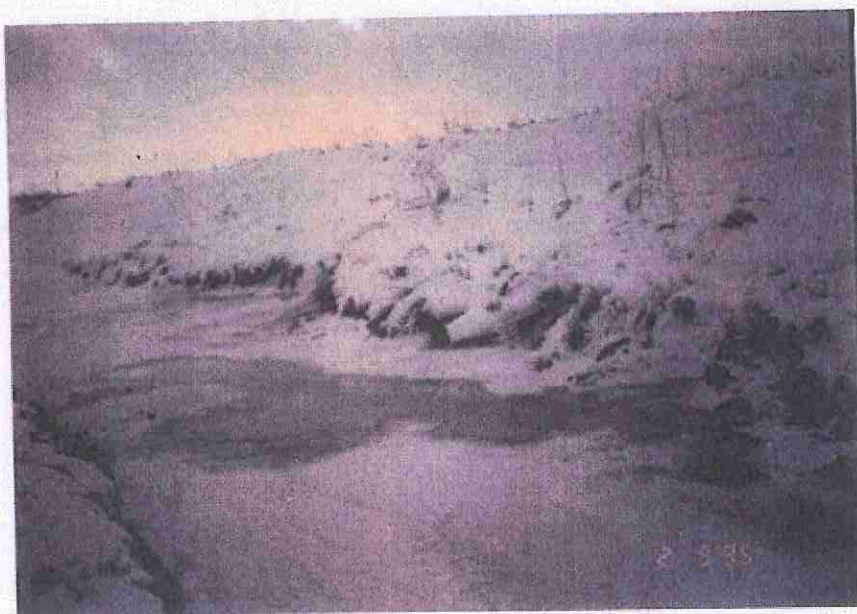
Photograph No: 12
Date: February 8, 1995
Orientation: Picture taken standing near the center of the site looking south at the east edge of the fill area and the east perimeter ditch
Description: Brown/red Leachate outbreaks discharging into east perimeter ditch from fill area.

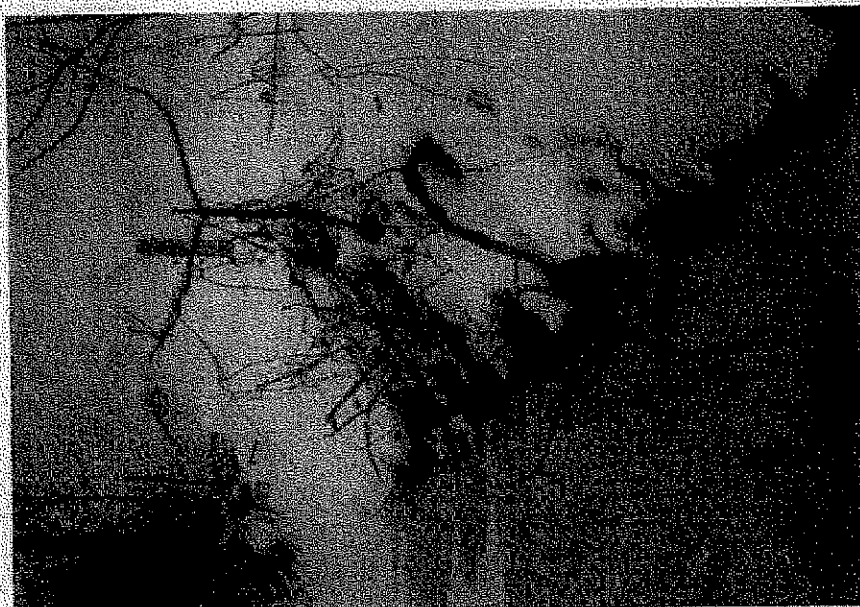
Photograph No: 13

Orientation: Picture taken standing near the high point (beginning) of the east perimeter ditch looking south.

Description: Brown/red Leachate outbreaks discharging from the fill area into east perimeter ditch where Columbia Gas transmission line enters the site.

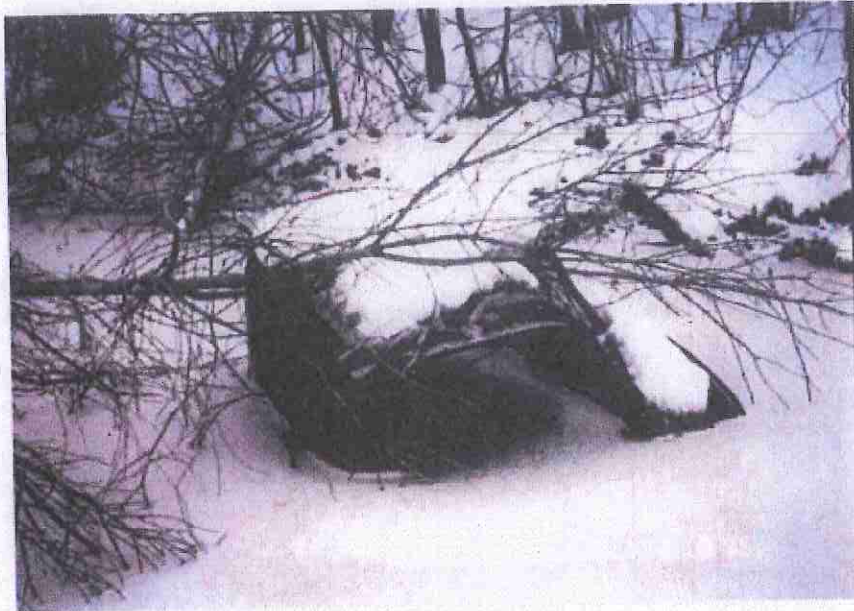
Photograph No: 15
Date: February 8, 1995
Orientation: Picture taken standing at the high point (beginning) of the east perimeter ditch looking south.
Description: Brown/red Leachate in east perimeter ditch. Cab from old pick-up truck submerged in leachate. Ditch is excavated into waste in this area.

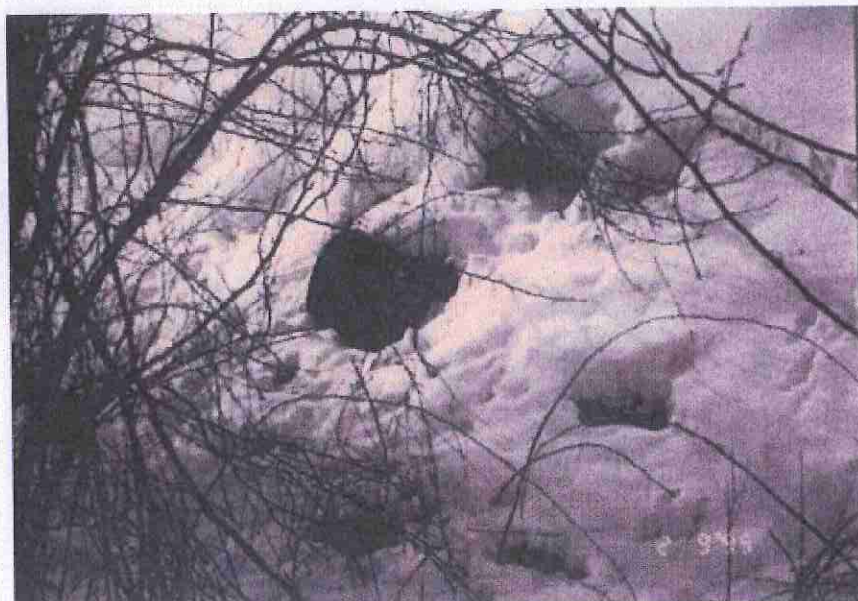
Photograph No: 16
Date: February 8, 1995
Orientation: Picture taken just south of the high point (beginning) of the east perimeter ditch looking southwest.
Description: 55 gallon barrel protruding from fill area.

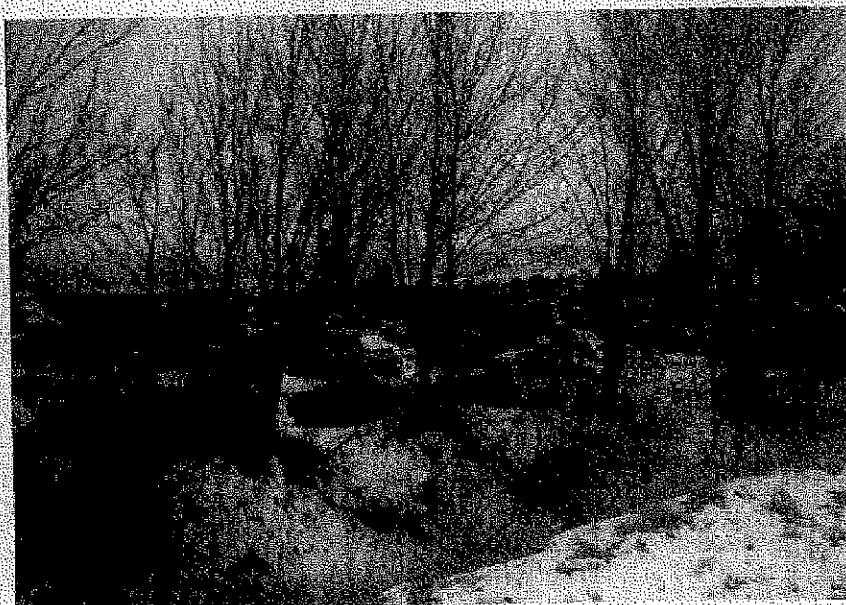
Photograph No: 20
Date: February 8, 1995
Orientation: Picture taken near center of site along Raccoon Creek looking northwest
Description: Tire pile at junkyard located along the western property boundary of the site.
